MARINA EL-ALAMEIN

PRESERVATION AND CONSERVATION IN 2005

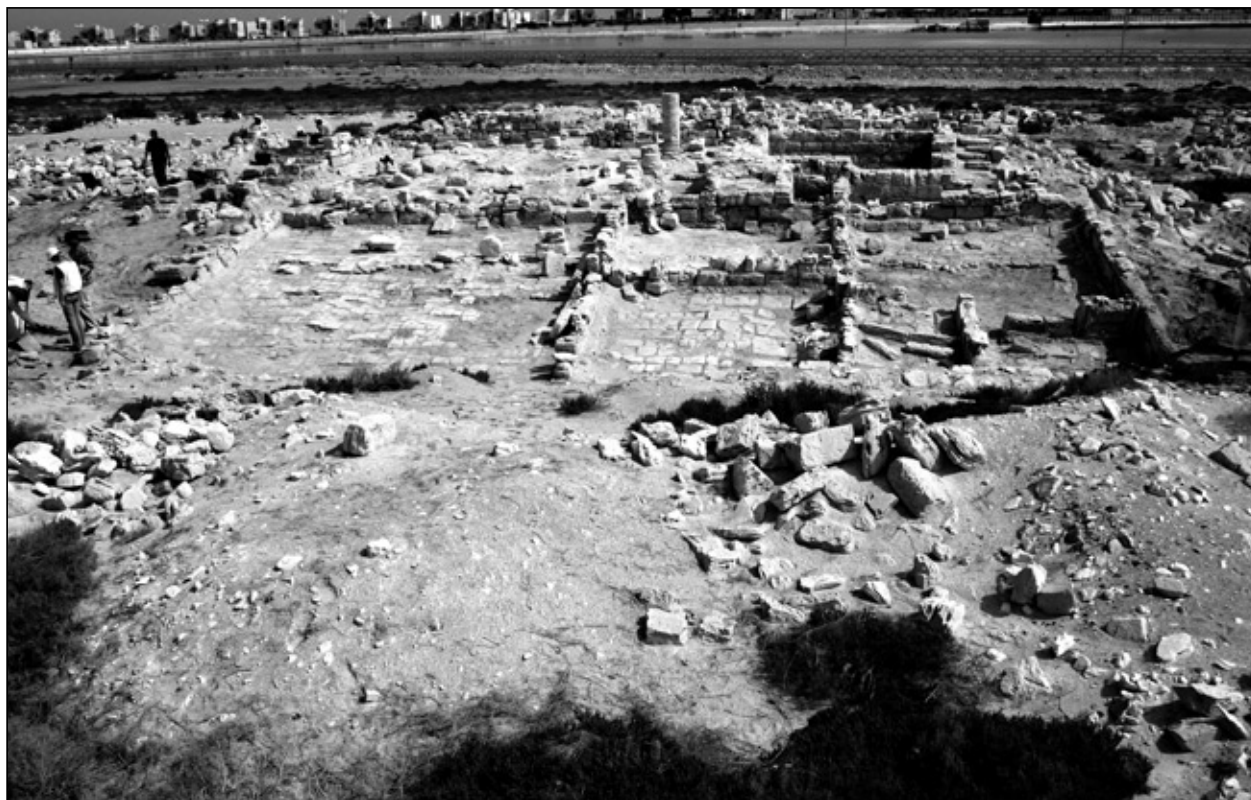
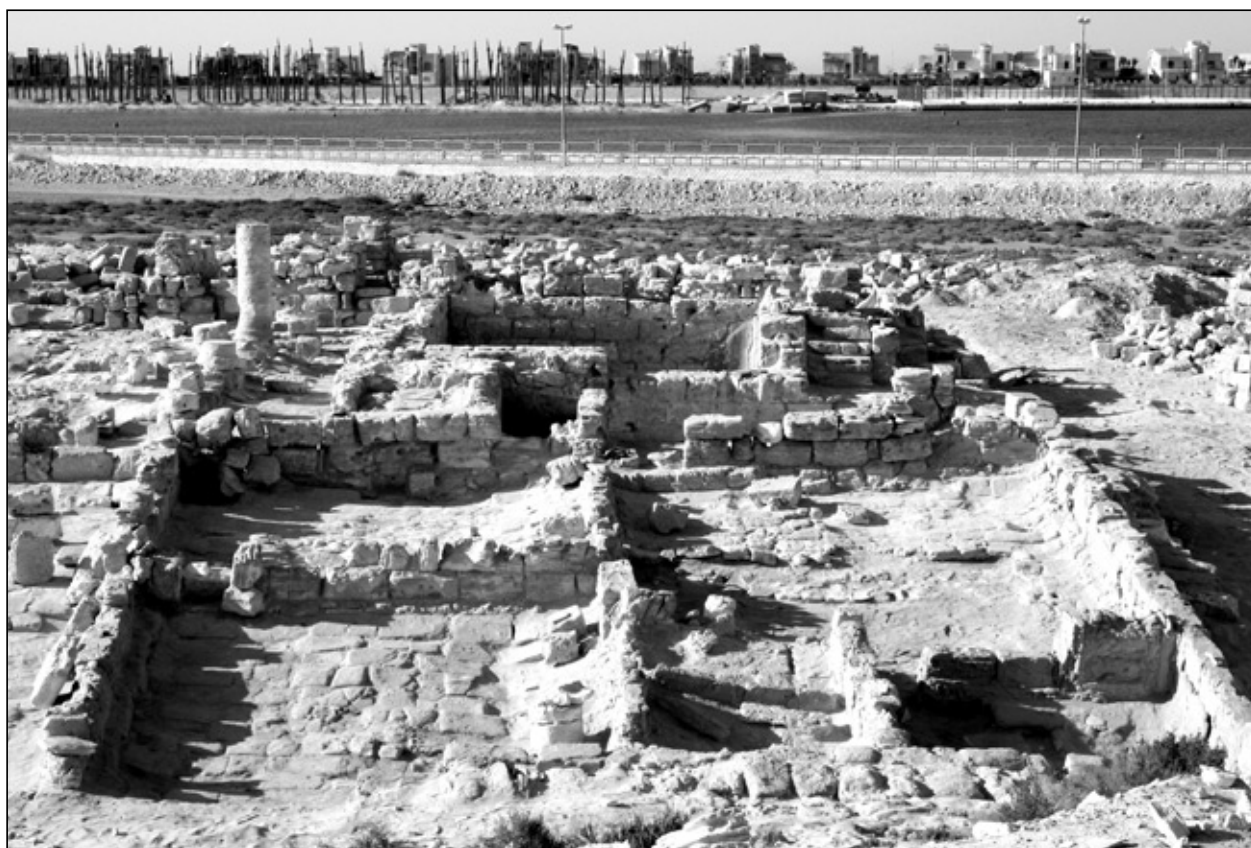
The building has suffered evidently from earthquakes and ground movement caused by other geological factors, resulting in a considerable distortion of the architectural appearance. Much subsidence of the original stone pavements is in evidence, especially in the courtyard (north portico of the peristyle) and in the area of rooms 4, 5, and 10 [*Fig. 3*]. Only the vaulting of the cistern under the floor in room 3 seems to be at the original level, but it has a deep E-W fissure that is pushing apart room 13 and basin 9. The perimeter wall also proved to be very poorly preserved, even missing entirely in places (especially in the eastern part of the house, in the vicinity of rooms 15, 14, 22, 13, 24). Room 6 appears to have been a projection, extending west, beyond the rectangular body of the house.

*Fig. 3. House H1. View from the south, before (top) and after the season
(Photo S. Medeksza)*

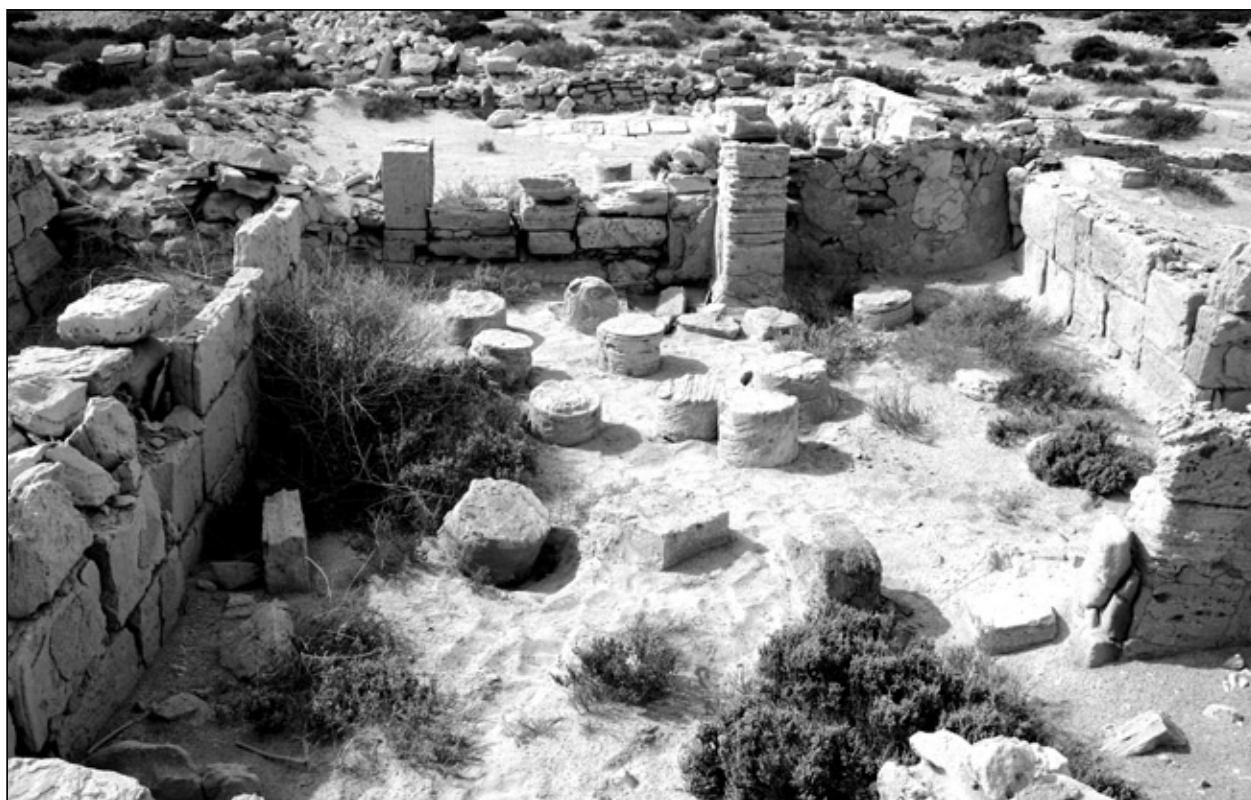
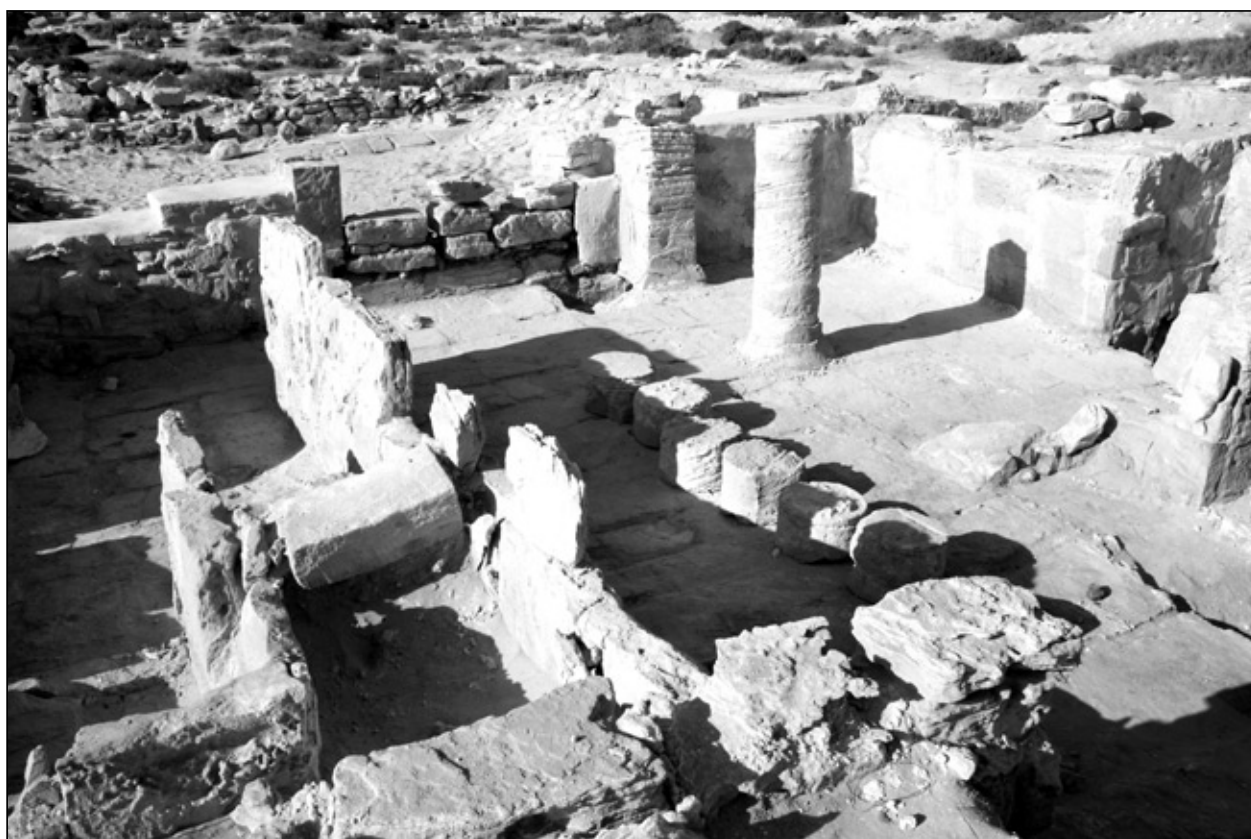
*Fig. 5. House H2. View from the south, before (top) and after the season
(Photo S. Medeksza)*

In 2005, all the walls surrounding the courtyard were consolidated [Fig. 5]. New jointing was carried out and the missing plaster completed. The broken-stone walls had the tops protected with the regular lime-cement mortar used by the mission.

The column was raised to a height of 1.20 m and will be completed next year.

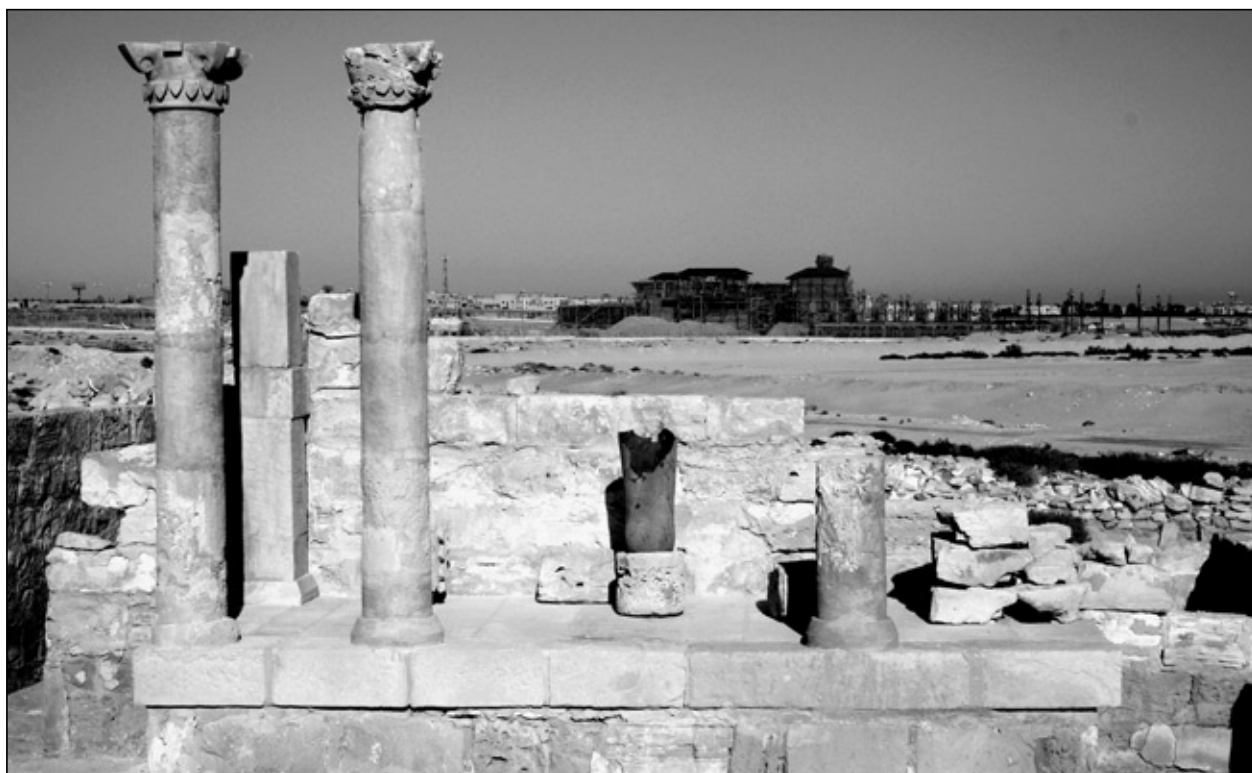
Fig. 6. Commemorative monument from House 21, after restoration work in 2005 (Photo S. Medeksza)

The commemorative monument in room 2, which had been restored to the top of the parapet walls in previous seasons, now underwent an anastylosis of the upper, decorative parts. Three of the four small columns, which together with the engaged pilasters had formed the portico, were re-erected on the platform measuring 4.00 by 2.20 m. Originally, each of the columns had consisted of four drums, the three bottom ones being 0.53 m high, the last one on top 0.45 m high; the diameter of these drums ran from 0.31 m at the bottom to 0.29 m at the top. One of the drums with preserved polychromy composed of a floral ornament, which underwent conservation in the 2000 and 2001 seasons, is intended for display in the local site museum. The other surviving

elements – five drums, a base and a capital, both 0.28 m – high were strengthened and completed with limestone of similar properties as the original.⁵ The small columns were raised using some new stone elements (four drums, three blocks from the pilaster, three bases and column capital⁶), the two columns on the south were raised to their full height, the third to the height of one drum above the base. A sizable section of the back wall of this commemorative portico and one of the engaged pilasters, 0.30 m to the side, was also reconstructed, but the surviving capital still waits to be put into place [Fig. 6]. The full height of the restored columns is 2.56 m. Further work on the back wall and pilasters, using surviving elements of the cornice, is planned for the coming season.

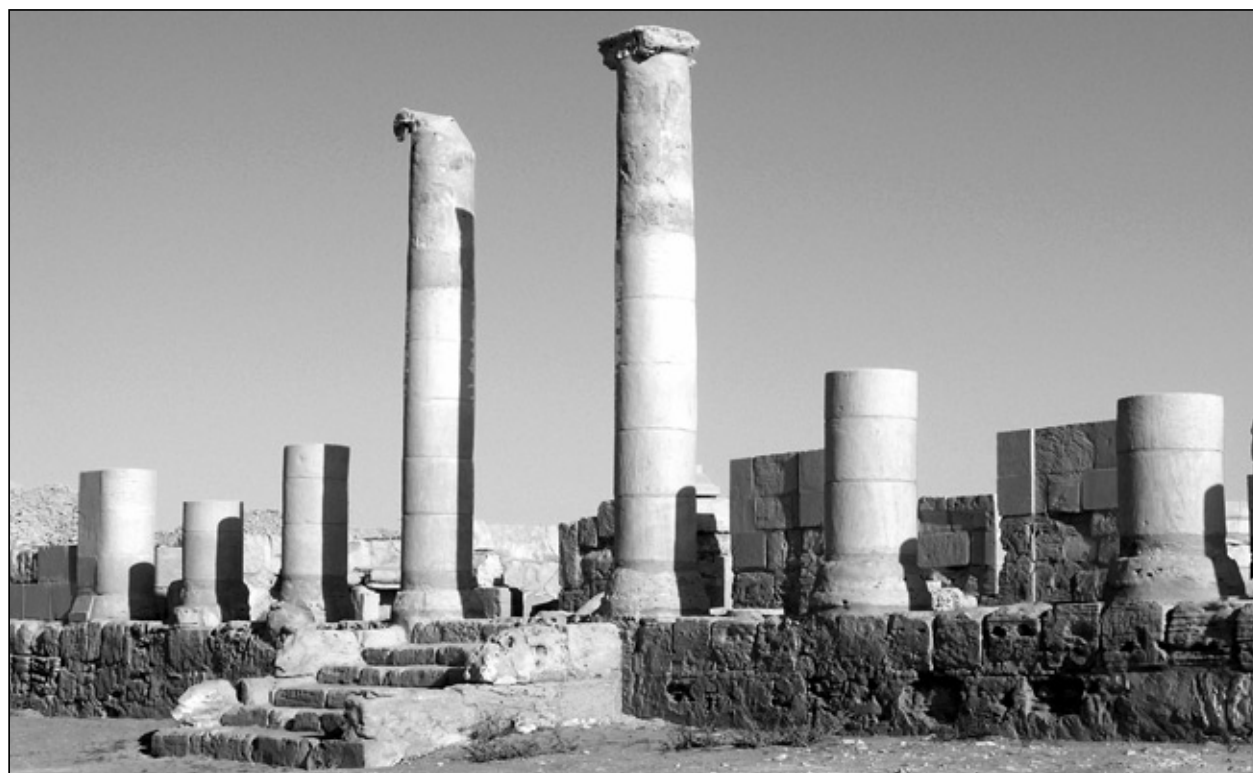
Fig. 7. *Hypogeum-Mausoleum T6, façade of the mausoleum after restoration work in 2005 (Photo S. Medeksza)*

Restoration work on the mausoleum of Hypogeum Tomb T6, discovered by the Polish Archaeological Mission in 1988-1998, continued with a further reconstruction of the columns of the front portico. In previous seasons these columns had been raised and restored to no more than 135 cm in height. Having some shaft drums from the upper parts of these columns (as suggested by the smaller diameter) and remains of a capital, it was possible this year to reconstruct the two columns framing the entrance to their full height of 3.25 m [Fig. 7].⁷ The lateral pillars with engaged columns were also raised by two blocks in the case of the eastern one and a single block in the case of the western one. Both the height and span of the portico are now clearly visible.

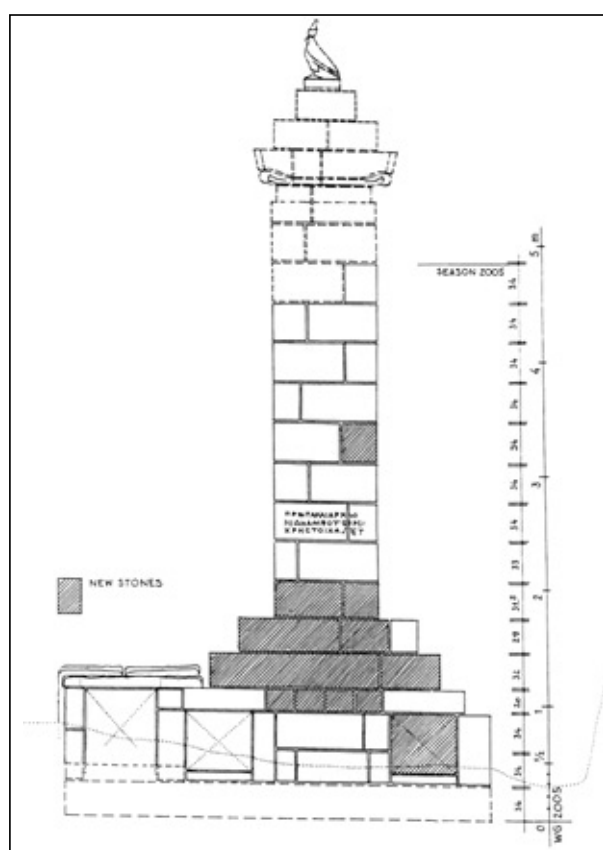
Fig. 8. Building-conservation work on tomb T12 in 2005 (Design W. Grzegorek, original drawing J. Dobrowolski)

The tomb, which was discovered in 1994 by the Polish Archaeological Mission,⁹ was cleared again in 2004 in preparation for the restoration project. This season, the eroded stone blocks in the three upper courses of the base on the west and south were replaced with new blocks. The original fill consisting of small rocks mixed with clay and sand was removed from the core of the substructure and in its place larger stone blocks in lime-cement mortar were introduced. Four of the limestone slabs (52x26x20 cm each) covering the loculi comprised within the base were replaced. Also, the lowermost course of the pillar was reconstructed in new

stone. A trial mounting of particular layers based on a project design prepared originally by J. Dobrowolski and updated by W. Grzegorek, permitted missing elements to be replaced with new ones made in old and new stone. The pillar was verified as measuring 0.91 by 0.91 m, with each course being 0.34 m high [Fig. 8].

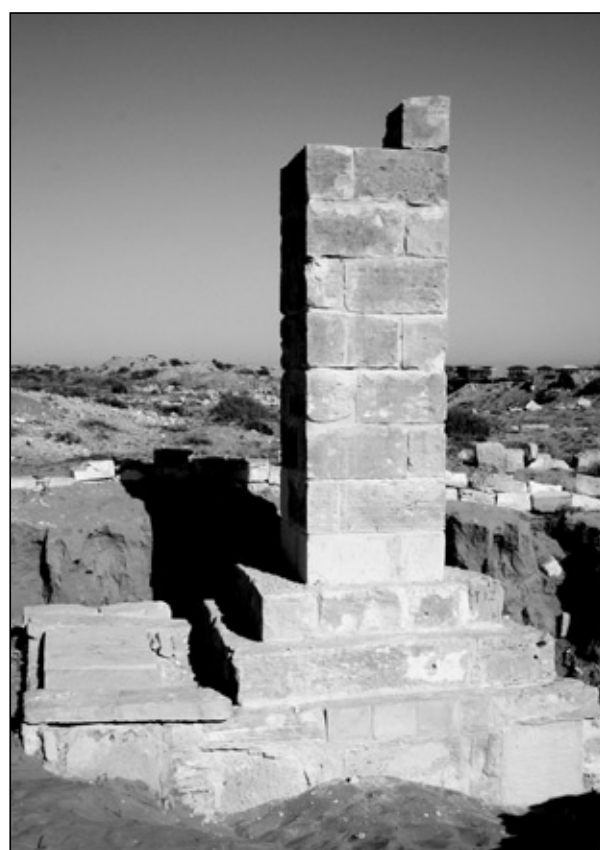
Fig. 9. Pillar tomb T12, state after reconstruction in the 2005 season (Photo S. Medeksza)

Eight courses of the pillar shaft were raised [Fig. 9]. Next year, the remaining three courses will be erected, plus the two-course capital and the course on top of the capital, which is the base under a limestone sculpture of Horus in falcon form, discovered during the earlier excavations, restored and kept in storage at the site.

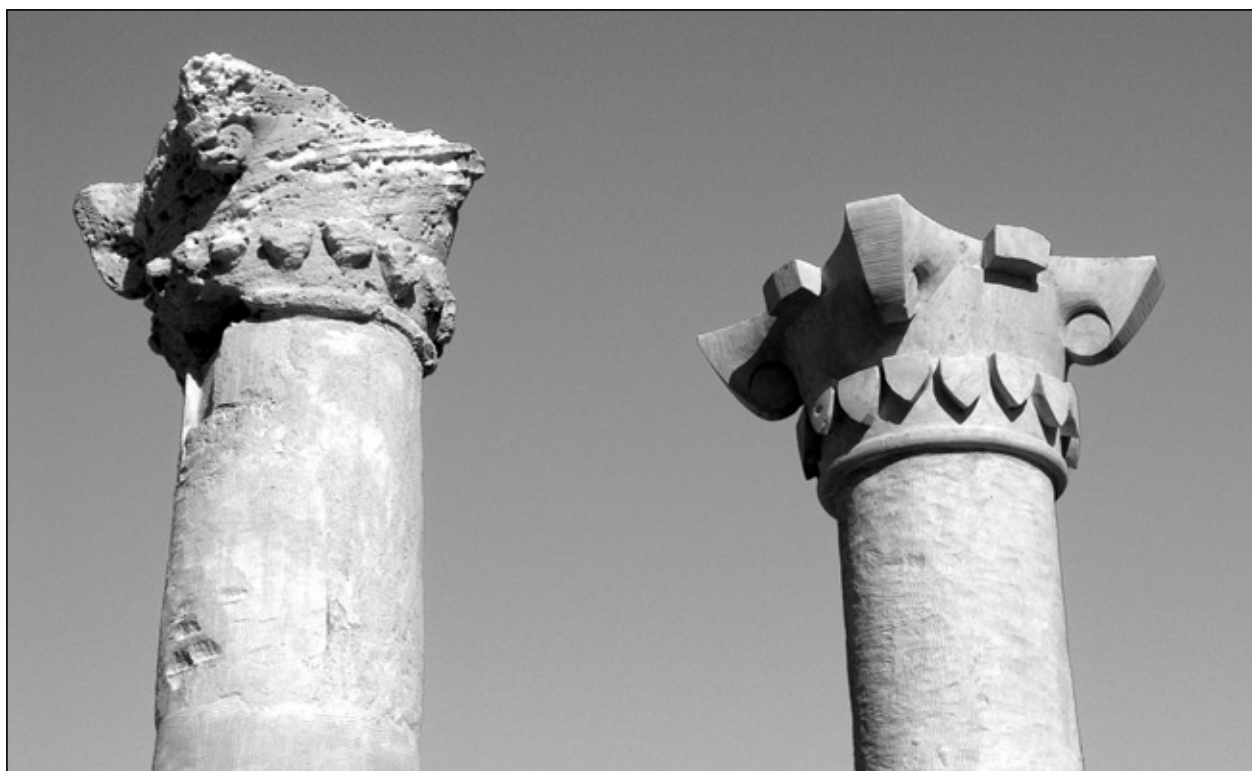
Fig. 10. Capitals from the commemorative monument in H21, after treatment (left) and reconstruction (right) in 2005 (Photo S. Medeksza)

The program calls for protection of the ancient substance, reconstruction of the original form of selected elements (determined by the needs of future display) and testing of specialist materials for use in the future. Objects for treatment were chosen from structures both in the town and the necropolis, including some which were a continuation of earlier activities, e.g. the base of a pilaster and capital in pseudo-Corinthian style typical of Marina, from the commemorative monument in H21, which were replicated in Heluan limestone, based on comparative analysis of surviving fragments and executed using traditional techniques [*Fig. 10*].

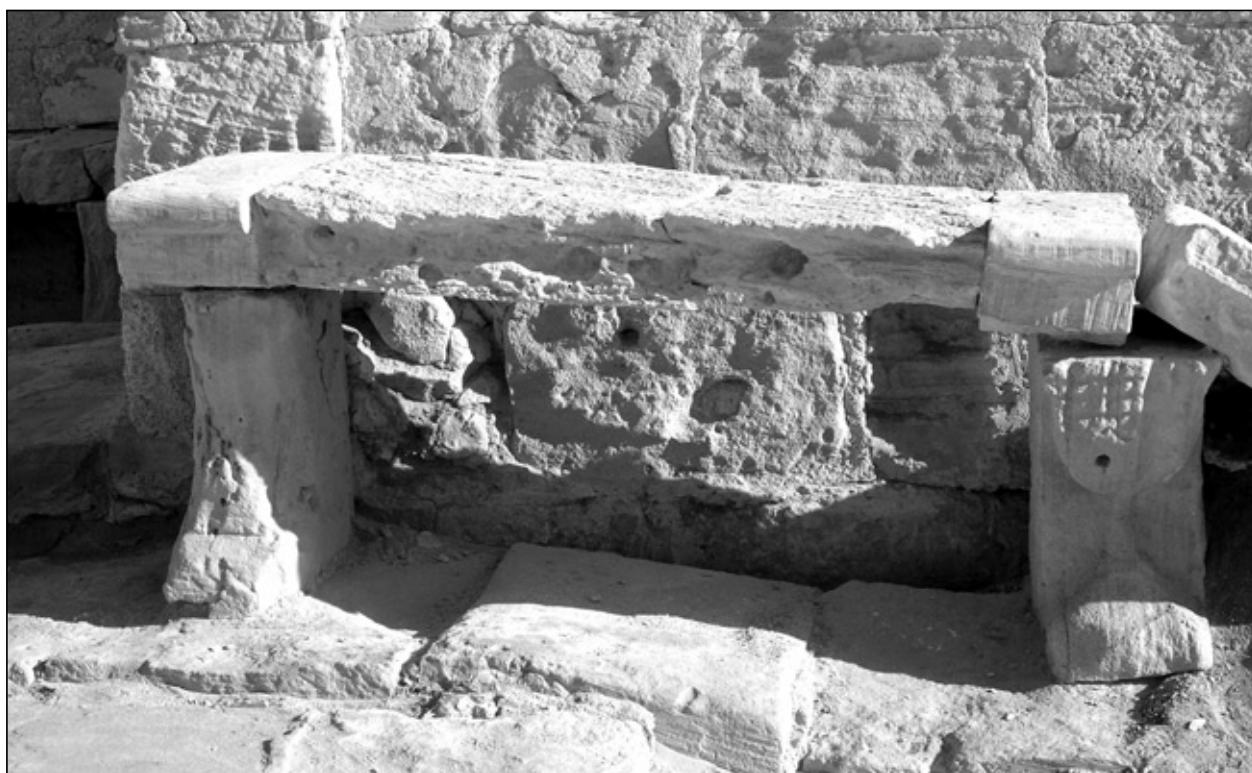
Fig. 11. Stone seat in the South Stoa of the main square, after conservation work in 2005 (Photo P. Zambrzycki)

Similar treatment was applied to the seats of benches in the South Portico of the Town Square. Surviving fragments were consolidated and the original appearance reconstructed in part. Stone replacements for missing elements were introduced based on a comparative analysis of surviving parts [*Fig. 11*]. The work will be continued in the coming season, once the remaining deposits under the benches are excavated.

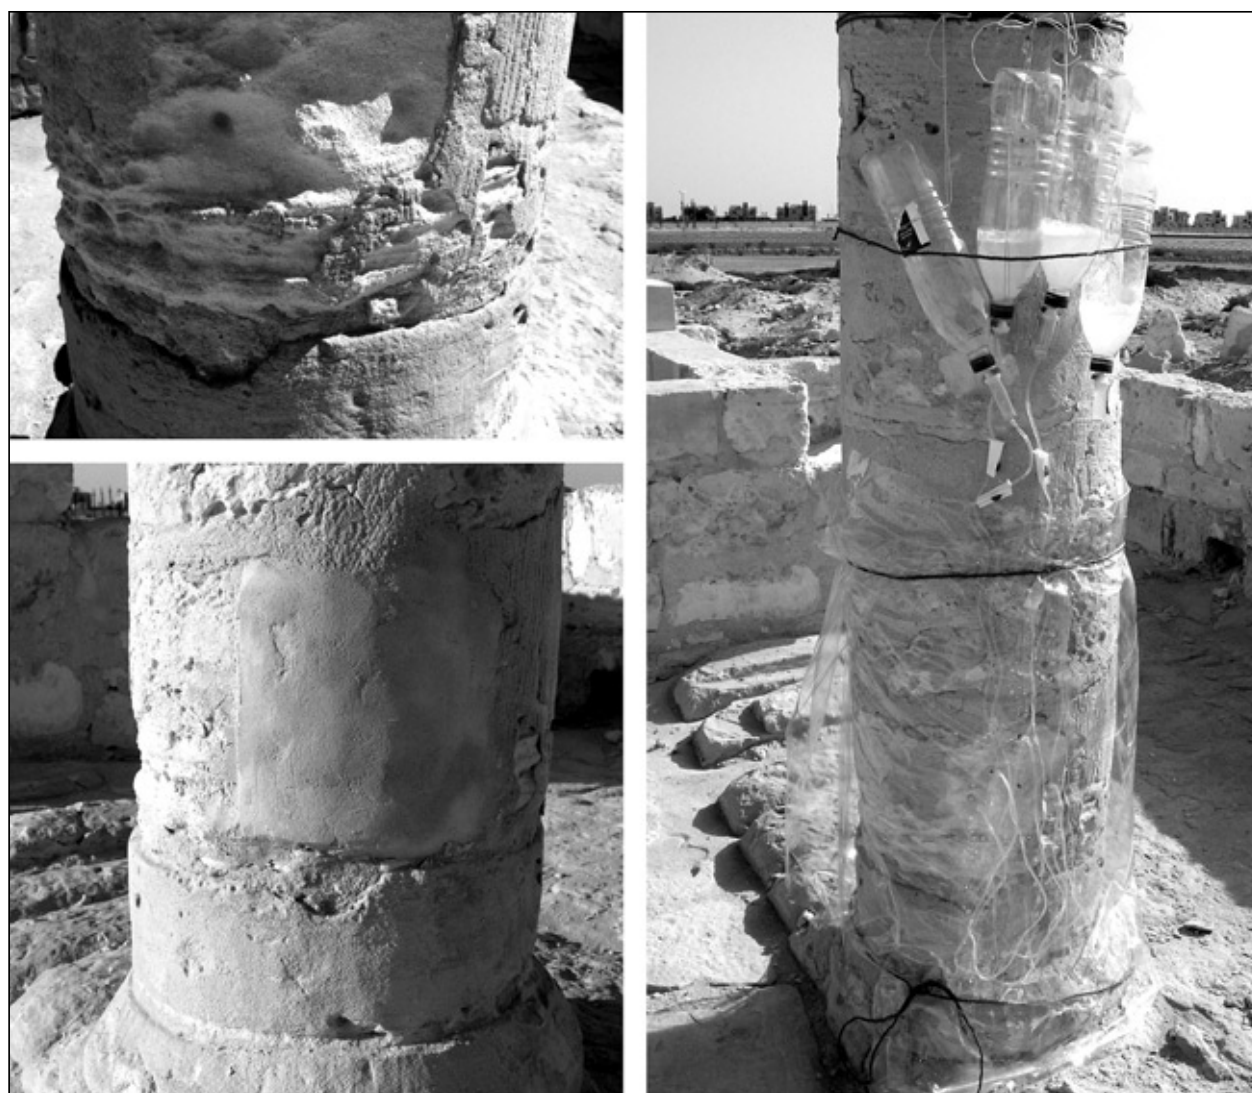
based on new materials was initiated in 2005. A major cause of on-site damage is the impact of an erosive seaside climate on faulty stone material of local origin. Substantial daily and seasonal variations in humidity and temperature levels result in granular disintegration, intensified at the absorption line. The process could have been escalated by the considerable salinity of the cement binder used so far, hence attempts to replace it with slaked lime. In chemical terms, slaked lime is also the better material because it corresponds to the stone used for the building blocks.

Fig. 12. Drum of a limestone column from H21, before (top left), during (right) and after trial conservation in 2005 (Photo P. Zambrzycki)

The object chosen for the research program was the lower drum of a column from room 1 in H21; tests included reinforcing and protecting the surface of the stone through a re-profiling with appropriate mineral mortars. The structure was re-inforced with a solution of dispersive lime, which was introduced by drop injection. Upon seasoning in stable conditions, the surface was covered with lime plaster containing quartz sand filler (1 part lime to 1.5 parts sand) [Fig. 12]. The material used was dispersed lime KALKINIEKTION by Kalk-Kontor-Germany. Actual conservation
